# Manhole Inspection Summary

Manhole # S37SS\_030MH

Insp Date: **12/21/06 1:39 PM**

**Location** Address: **2622 GREENMOUNT AVE**

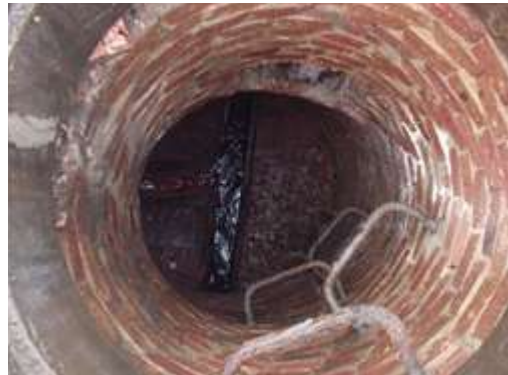
Top View

Corroded steps. Evidence of surcharge - Bench debris.

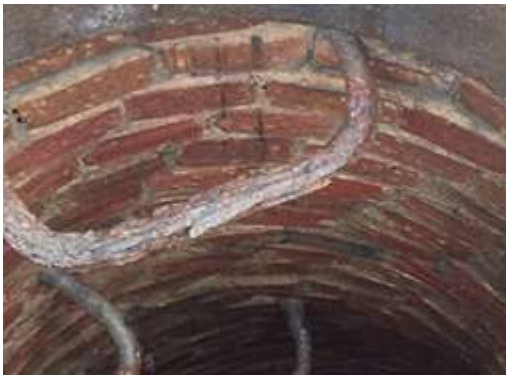
Defect

Frame leaks. Adjustment deterioration and infiltration. Corbel and Barrel infiltration.

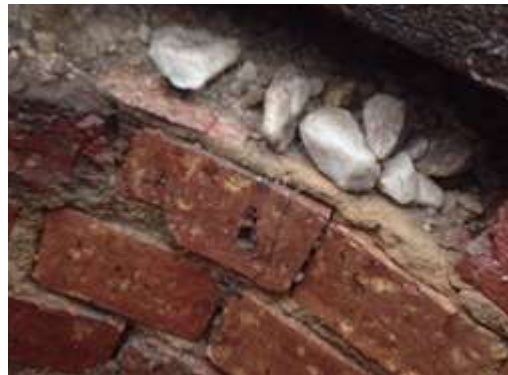
Defect

Frame leaks. Adjustment deterioration and infiltration.

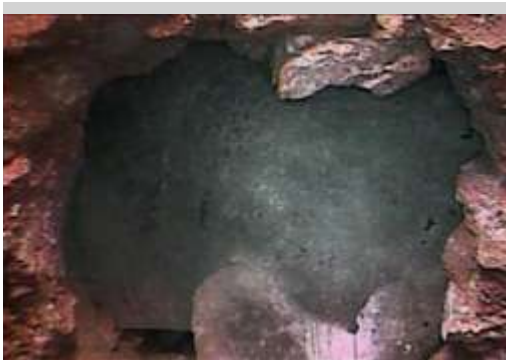
Defect

Comments **There is a large hole in the Corbel. The O12 and the I9 pipe seals are not flush to the pipes.**

Hole in the Corbel

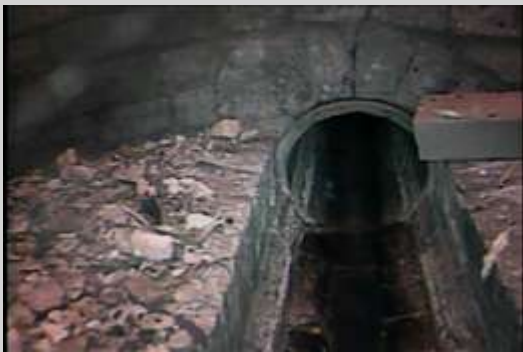
### 8 in. Circular Gravity Sewer Pipe Out @ 12 O'Clock

Deposits: ☐ None ☐ Mud ☐ Sludge ☐ Debris ☒ Grease

Silt Depth: **0** (in.) Deposits Extent: **Light**

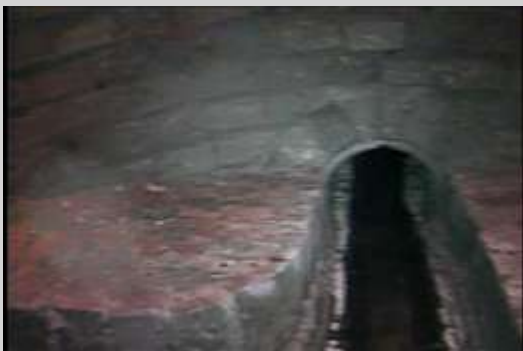
### 8 in. Circular Gravity Sewer Pipe In @ 6 O'Clock

Deposits: ☐ None ☐ Mud ☐ Sludge ☐ Debris ☒ Grease

Silt Depth: **0** (in.) Deposits Extent: **Light**

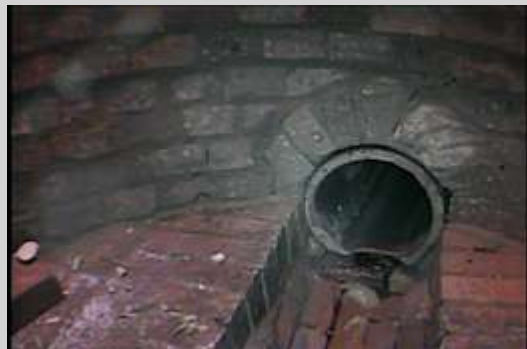
Pipe In @ 9 O'Clock

Channel deterioration.

Infiltration: **Evidence**
